Todorovic, J., Torsæter, M., Opedal, N., Wiese, B., Martens, S. (2014): Characterization of CO₂ Pipeline Material from the Ketzin Pilot Site. - *Energy Procedia*, 63, p. 2610-2621.

GHGT-12

Characterization of CO₂ Pipeline Material from the Ketzin Pilot Site

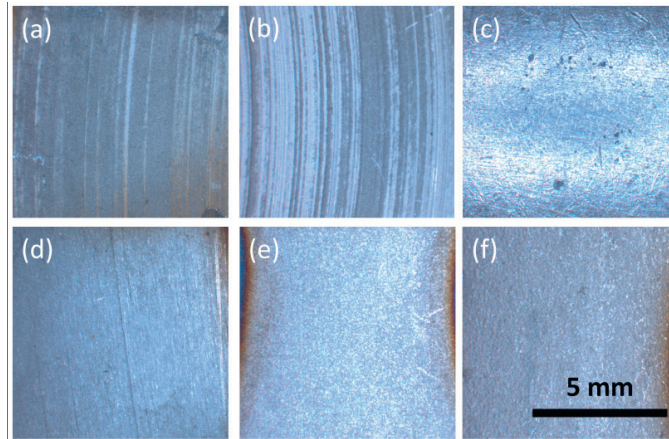
By visual inspection of pipe edges after cutting, it was observed that neither erosion nor corrosion penetrates deep into the bulk stainless steel. Figure 2 shows optical microscope images of inner surfaces of all four samples and outer surface of sample 2. It is apparent that the pipes have different appearance of inner and outer surfaces. The outer surface (Fig. 2c) has more scratches and is metallic grey in colour. All inner surfaces have a slightly different colour. Otherwise, no visual signs of corrosion were observed. The bent section of sample 1 (Fig. 2a,b) exhibited a different colour on the inside (brownish to dark grey) compared to the other samples (grey). This can be due to welding or pipe bending prior to CO_2 flow. In addition, the inner surface of sample 1 at the bent section appeared to have distinct dark lines along the flow direction. On the inner surface of sample 2 (Fig. 2d) some similar weak lines can also be observed. This is in contrast to samples 3 and 4 (Fig. 2e,f), which both seem to have a homogeneous roughness.

Fig. 2. Optical images of the pipes after cutting: (a) Sample 1 sharp section, inner surface, (b) sample 1 top section, inner surface, (c) sample 2 blunt section, outer surface, (d) sample 2 sharp section, inner surface, (e) sample 3 top section, inner surface, (f) sample 4 top section, inner surface.

Little corrosion was visible on the pipe surfaces by optical inspection (Fig. 2), and the pipeline can thereby be said to have withstood the environment to which it had been exposed during the five years of CO₂ injection. Various SEM techniques and a profilometer were used to map the surface structure at micro-scale, chemistry and roughness of the pipe sections. This revealed some signs of corrosion over the whole inner surface for all samples, especially in

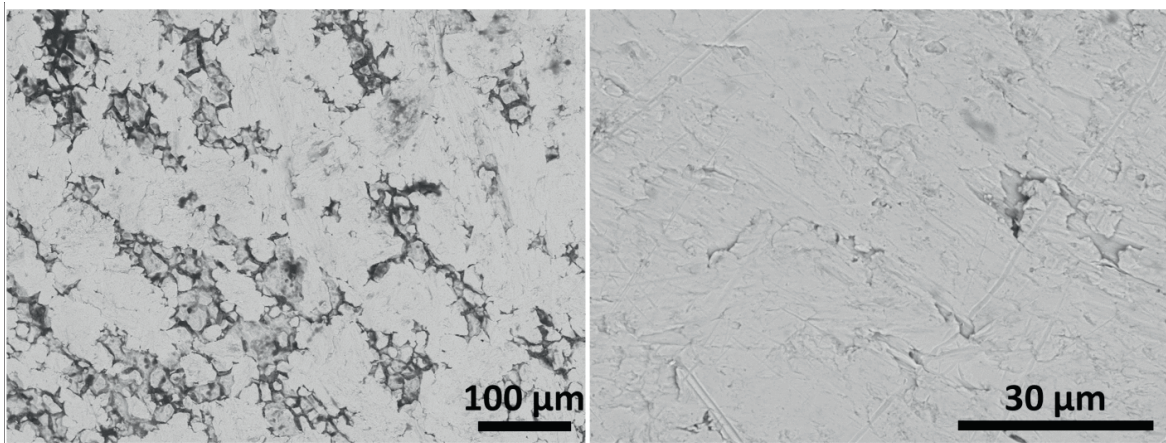
Fig. 3. BSE images at two different magnifications of the outer surface, that has not been in contact with CO₂, of the blunt sample 2.

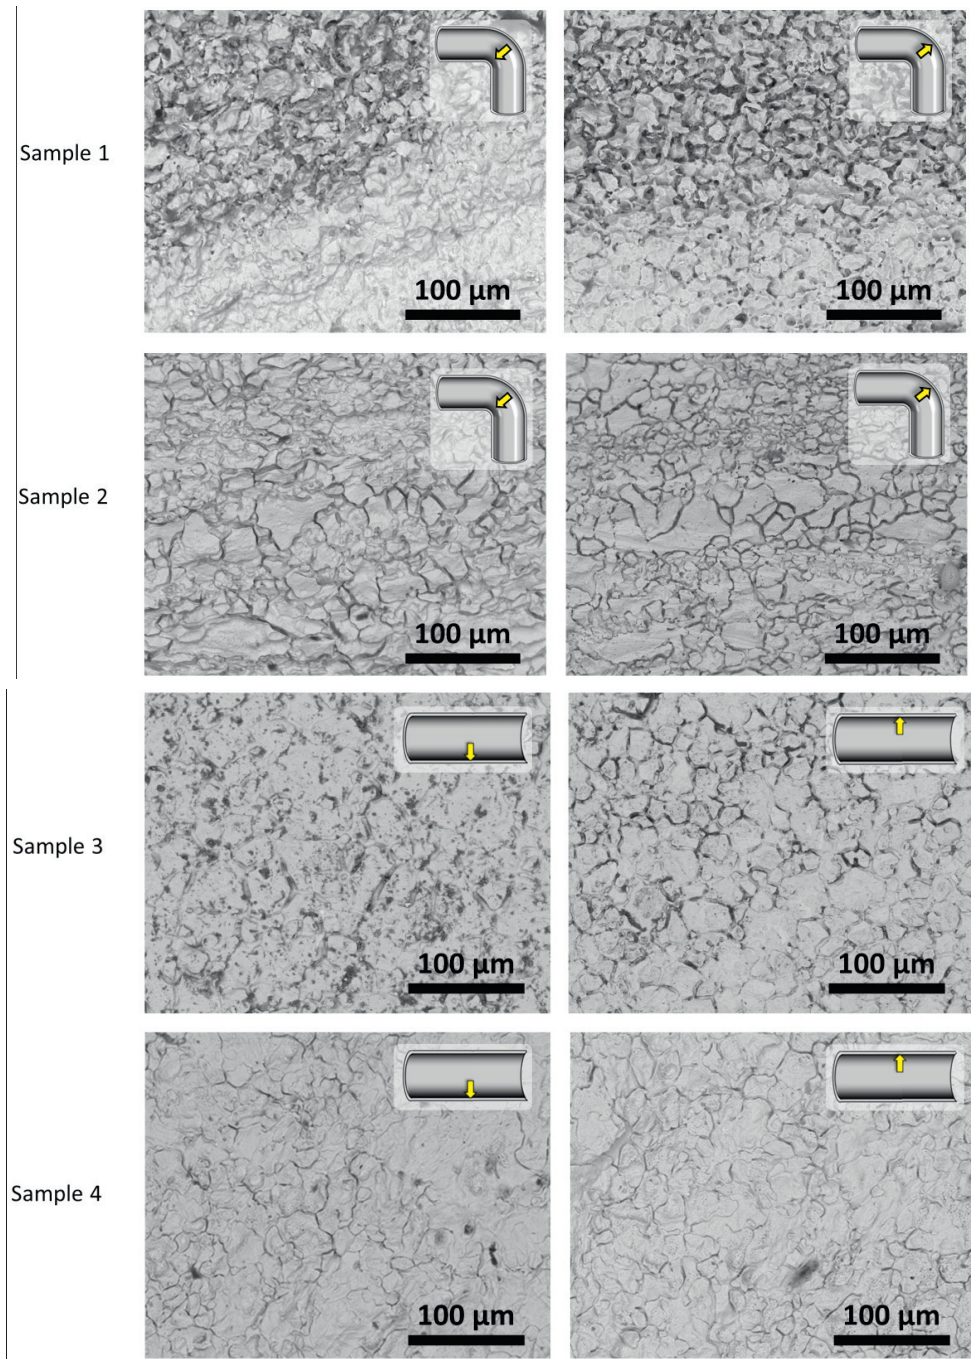
Several regions of the inner surface of the CO₂ transport pipeline were also analyzed by SEM, and the results are summarized in Fig. 4. For samples 1 and 2, the sharp and blunt bent sections are compared, while for samples 3 and 4 the top and bottom sections of straight pipe sections are compared. The location in the pipe is indicated in the top right corner of each figure. As seen from this overview figure, all samples display a cracked surface layer, which is typically the first sign of onset of corrosion. Intergranular corrosion, with loss of material in between grains, is also visible in all the samples. Overall, sample 1 has the most corroded inner surface – followed by sample 2. The grooves in the cracked surface layer appear to be shallowest in sample 4.

There are little differences in corrosive attack between the sharp and blunt sections of the bend in samples 1 and 2. For sample 1, the sharp section had a higher density of dark/brownish lines than the blunt one (also visible by eyes/in optical microscope, Fig.2), but the degree of corrosion was similar. In Fig. 4, a transition between a dark line and lighter region in between the lines is shown from sample 1. Corrosion degree of both sharp and blunt sections of sample 2 appears similar to samples 3 and 4, except that the grooves seem to be deeper. Further, as Fig. 4 displays, there was little or no difference in corrosion between the top and bottom sections of the straight pipes (samples 3 and 4) which were overall less attacked by corrosion than the blunt and sharp sections of samples 1 and 2.

Fig. 4. BSE images of the inner surfaces of all the samples described in Table 1. For the bent pipe samples the sharp and blunt section of the bend is compared, while for the straight pipe samples the top and bottom section of the pipe is compared.

the bent sections of samples 1 and 2 (Figs. 2 and 4). It is expected that the bent region of the pipe is most severely attacked by corrosion, as the pipe bending procedure usually involves production of stresses in the material. These bending stresses are especially severe if the pipe is cold formed [14]. In a bent region the material will be subjected to tensile stresses which are known to enhance corrosion in stainless steels [15].

The sample collected close to the inlet of the ambient air heater (Sample 1) was the most corroded one (Fig. 4). This sample was exposed to liquid CO_2 and subject to lowest temperatures (about -15°C) and most constant temperature conditions during operation. Sample 2 which was also exposed to liquid CO_2 but ambient temperature and its natural fluctuations, was the second most corroded sample. Samples 3 and 4, where gaseous CO_2 with higher temperatures (about 30 to 45°C) had flowed during standard operation, exhibited lower degree of corrosion. Physically, this could be based in a higher activity of residual water and formation of carbonic acid. Higher temperatures in contrast correlate with lower corrosion, which supports the former hypothesis.

Yet, the main conclusion from this work is that the chosen pipeline material was sufficiently resistant to CO_2 corrosion for its purpose. As it is difficult to predict whether or not prolonged CO_2 exposure would cause non-linear corrosion rates our results suggest that care should be taken to protect bent pipeline sections and pipe sections exposed to low temperatures/liquid CO_2 when similar metals/conditions are used for longer operational lifetimes.

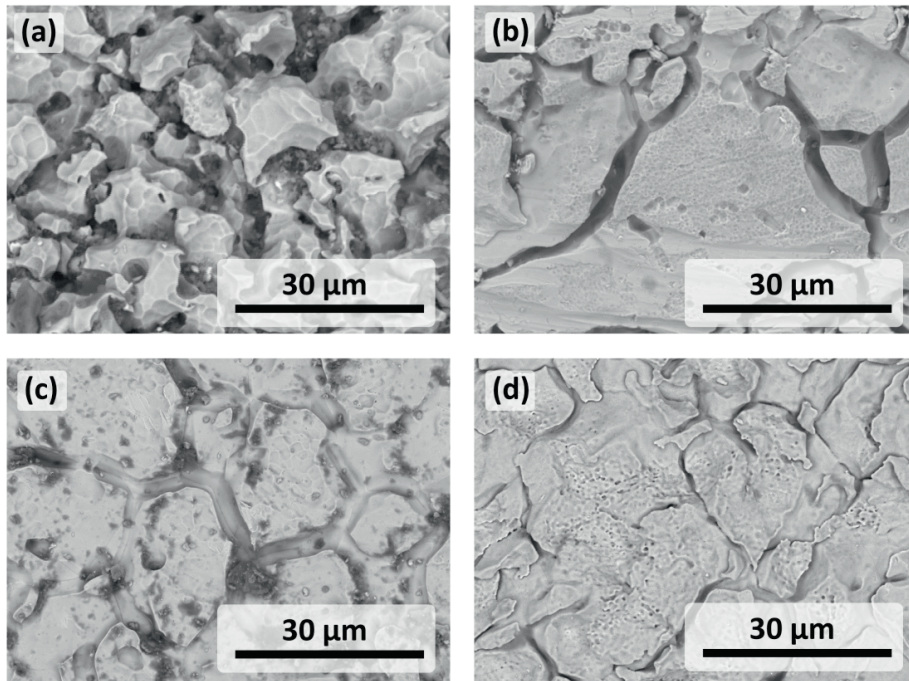
Higher magnification BSE images in Figure 5 show different types and degrees of corrosion observed in the four samples. This figure depicts especially corroded areas. Sample 1 is dominated by strong intergranular corrosion, while for sample 2, deep grooves of intergranular corrosion are visible. Sample 3 displays signs of intergranular corrosion as well, but the grooves are not especially deep. For sample 4, some shallow intergranular corrosion was observed. Not all grains were separated in samples 3 and 4 – so what we observe is most likely only the onset of intergranular corrosion. The micro-sized holes or craters on grain surfaces (not at their boundaries) confirm that there is also some pitting corrosion on most of the surfaces. Some large pitting craters are visible for sample 1 (Fig. 5a), and some smaller and more shallow ones for samples 2, 3 and 4 (Figs. 5b,c,d). The particles (dark) in between or on top of the grains, as seen in Fig.5(a,c) may be corrosion products or contamination or both.

Fig. 5. High magnification SEM images of the most corroded regions of the inner surface for each of the samples. (a) Sample 1, (b) Sample 2, (c) Sample 3 and (d) Sample 4.

Intergranular corrosion was the dominant form of corrosion, but some pitting corrosion was also observed (Fig. 5). The intergranular regions were either voids or including particles containing carbon and oxygen (Fig. 6). Auger spectroscopy indicated that the protective chromium oxide layer was severely damaged (Fig. 7). As seen in Figs. 5 and 7, some grains are more severely attacked by pitting corrosion than others. This is likely to be coupled to the grain orientation, as some crystal orientations are more susceptible to corrosion than others [17].

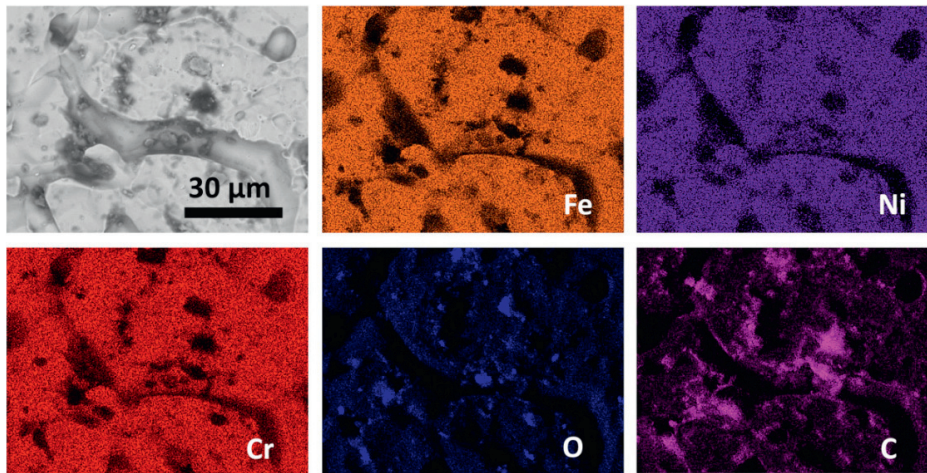
The surface composition of the different samples was studied by two analytical techniques, EDX and Auger spectroscopy. Both techniques confirmed the elements present in the stainless steel grade used in the pipeline, and revealed that all samples contained some carbon on the surface. Figure 6 depicts typical EDX maps from the pipeline with the most abundant elements in addition to carbon and oxygen. The latter two were included as they were the main constituents of the corrosion products or possible contamination or protective oxide layer on the surface. The main elements (Fe, Ni, Cr) are present overall, i.e. their EDX maps are matching well the corresponding BSE image in Fig.6. However, overall weak O signal (with specific spots of higher counts) indicates depletion of the protective chromium oxide layer, which is characteristic for ongoing surface corrosion. The carbon could originate from contamination or corrosion products or both. Note that it is impossible to determine the exact composition of possible corrosion products by using only EDX in SEM.

Fig. 6. BSE image and EDX mapping of the inner surface of sample 3. The main elements in the stainless steel are included in the mapping. Oxygen and carbon are shown as well, as these were prominent in the oxide layer and corrosion products/contamination.

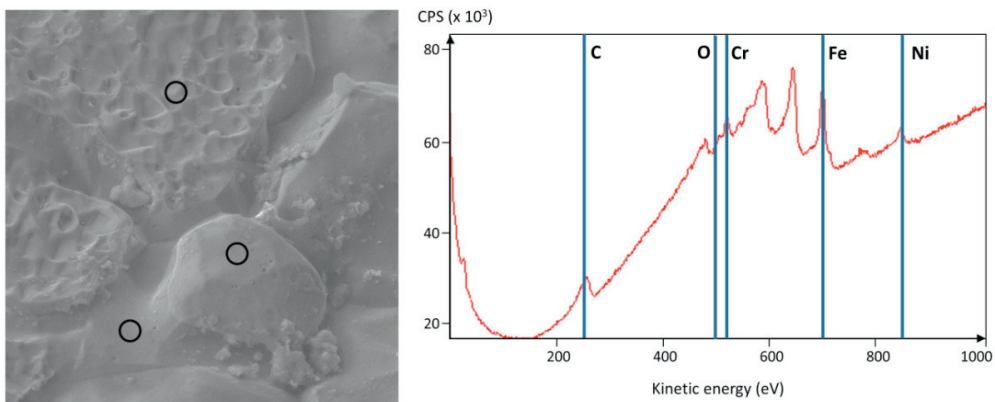
The surface composition of sample 3 was analyzed using Auger spectroscopy, and the results are depicted in Fig. 7. Initially, strong C peak and weaker O peaks were dominating the Auger spectrum (Fe, Cr and Ni not detected), indicating carbon contamination at the surface. After 8 minutes of sputtering to clean the sample, C peak was drastically reduced. Fe, Ni and Cr peaks then emerged, but Cr and O peaks were rather weak compared to Fe and Ni. The opposite would be expected if chromium oxide layer was preserved on the surface. The weak Cr and O peaks at the surface indicate that the protective chromium oxide layer has been damaged or even completely eroded. This is in line with the EDX results.

Fig. 7. SEM image of sample 3 indicating points on the surface analyzed by Auger spectroscopy. All points gave spectra similar to that depicted on the right, where the main peaks of the elements are marked with blue lines. Secondary (lower energy) peaks of Fe, Cr and Ni are not denoted.

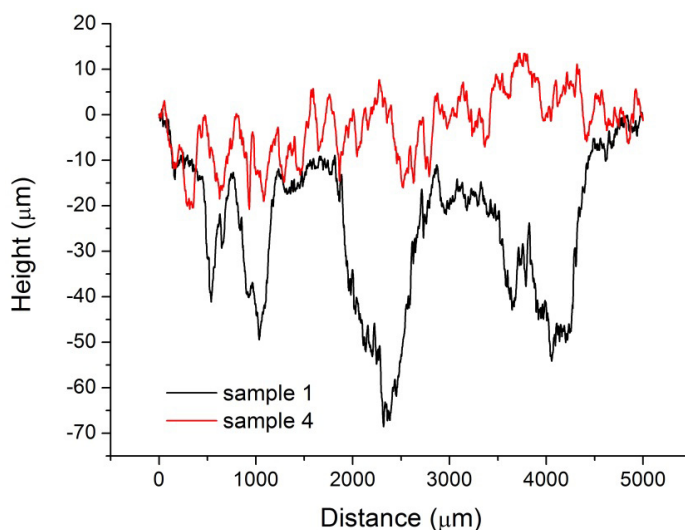
A typical surface height profile, represented by sample 4, and surface profile across the dark/light lines for sample 1 are shown in Figure 8. Here sample 4 represents the case where roughness is independent of CO₂ flow direction (samples 2, 3, 4). The average peak-to-valley distance was about 20 μm , which is an estimate of corrosion depth.

Sample 1 had a similar height profile to sample 4 when scanned along dark lines or in between them, as seen in Fig. 2(a,b). However, when scanned across the lines, the profile changes drastically, as seen by the black plot in Fig. 8. Drop in height (valleys) correspond to the dark lines, while peaks to the light regions in between. This means that the dark lines as seen by eye/optical microscope are actually furrows. This is also reflected in roughness values: about 14 μm across the furrows, and 2.2 – 4.7 μm along. The peak-to-valley distance in this case is about 70 μm , as seen in Fig.8, significantly larger than in sample 4.

Fig. 8. Surface height profiles of samples 1, across the lines as seen in Fig.2(a,b), and sample 4.

The deep furrows (up to 70 μm) at the bent section of sample 1 are unlikely to be caused by the flow pattern of the CO_2 mixture through so-called erosion corrosion [16], since the furrows exist evenly distributed on the inner surface of the bent section and not at all in the straight sections. These furrows may have originated from the initial pipe processing, and subsequently corroded due to CO_2 flow. In addition, it would not be expected to observe a high degree of erosion with a fluid composition with just a small amount of (or no) solid particles. A possible explanation for the increased corrosion on the sharp section of the bend in sample 1 is that the process is dependent on adsorption of molecules to the surface, a process which again could be dependent on the fluid velocity or phase (liquid vs gaseous).
