Gawel, K., Todorovic, J., Liebscher, A., Wiese, B., Opedal, N. (2017): Study of Materials Retrieved from a Ketzin CO₂ Monitoring Well. - *Energy Procedia*, 114, pp. 5799—5815.

13th International Conference on Greenhouse Gas Control Technologies, GHGT-13, 14-18
November 2016, Lausanne, Switzerland

Study of materials retrieved from a Ketzin CO₂ monitoring well

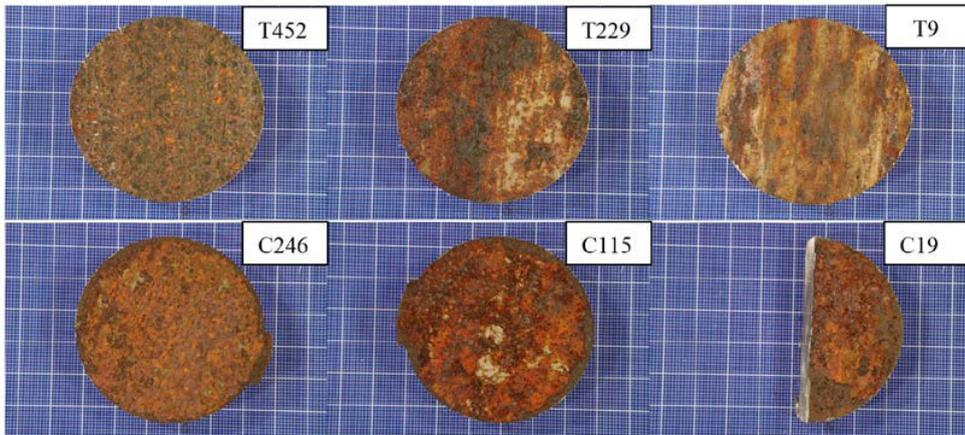
The macroscopic images of the samples cored out from casing and production string from Ketzin Well 202 (Ktzi 202) are presented in Figs. 12 and 13. Rust layers were present at both internal (Fig. 12) and external (Fig.13) surfaces of production string (T) and casing (C) samples. Rust layers present on the internal side of the casings were thick and showed tendency to peel off. It was noticeably thicker than the rust layer on the production string. The rust spots on two uppermost production strings seemed to be aligned along a certain direction that could possibly be fluids flow direction in the production string. This alignment was not observed for the deepest production string sample T452. This alignment can either be associated with a mechanical abrasion upon fluid flow or direction specific rusting on CO₂ flow through the production string. The colour of rust at casings both internal and external sides was dominated by red-brown while the colour of production strings had admixtures of brown-black. The red-brown colour is characteristic for hematite while the black admixture may suggest presence of magnetite in corrosion products. The external production string surface was the darker the deeper in a well the sample was residing. The external surfaces of casings had a comparable colour and roughness regardless the depth they were retrieved from.

Fig. 12. Images of internal surfaces of casing (C) and production string (T) samples retrieved at different depths.

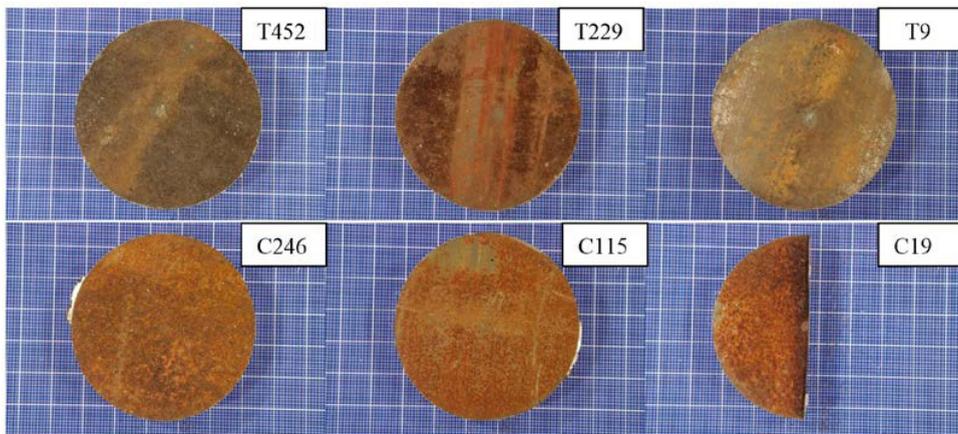
Fig. 13. Images of external surfaces of casing (C) and production string (T) samples retrieved at different depths.
