Mechanical and optical tests of Zeiss THEO 010 and 020 nonmagnetic theodolites during the IAGA workshop 2018 at Conrad Observatory

Jürgen Matzka, Thomas Wenger, Jörg Krüger, Achim Morschhauser

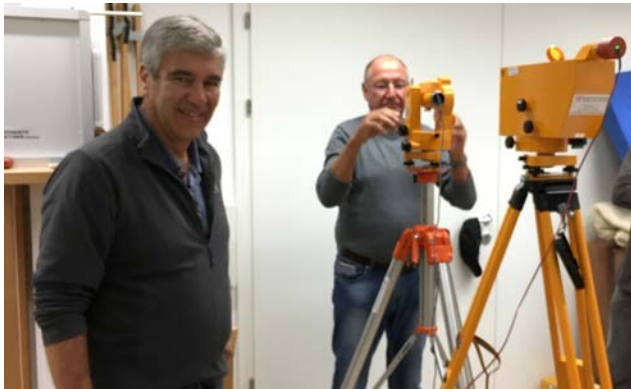
Figure 1: Test of a steel-free converted Zeiss THEO 020A theodolite during the IAGA Workshop 2018. From left to right: Alan Berarducci, Jörg Krüger, Theo 020A, Carl Zeiss Jena Ni 002 collimator with green light source at ocular.

The tests were performed by JK who was responsible for final control and adjustment at Carl Zeiss Jena. The tests started by mounting the theodolite on a tripod opposite of a surveyor's level (Figure 1) and a first visual inspection of the instrument.

Test with surveyor's level. A Zeiss Ni 002, the most accurate surveyor's level (compensator) by Carl Zeiss Jena (0.2 mm on 1 km or 0.04'' deviation) was used to determine horizontal (collimation) or vertical circle errors of the theodolites tested (Figure 1). By looking with the telescope to be tested into the objective of the Ni 002, a cross hair identical to the THEO cross hair can be seen. A tilt of the cross hair and an error of the vertical index can be diagnosed by this method. The angular difference between face left/face right (sensor up/sensor down) observations of that cross hair is noted. Small errors could be corrected by adjusting the cross hair of the THEO. In this process, all spirit levels were adjusted.
